## Roadster 2000 clutch control

## by Paul Alting van Geusau

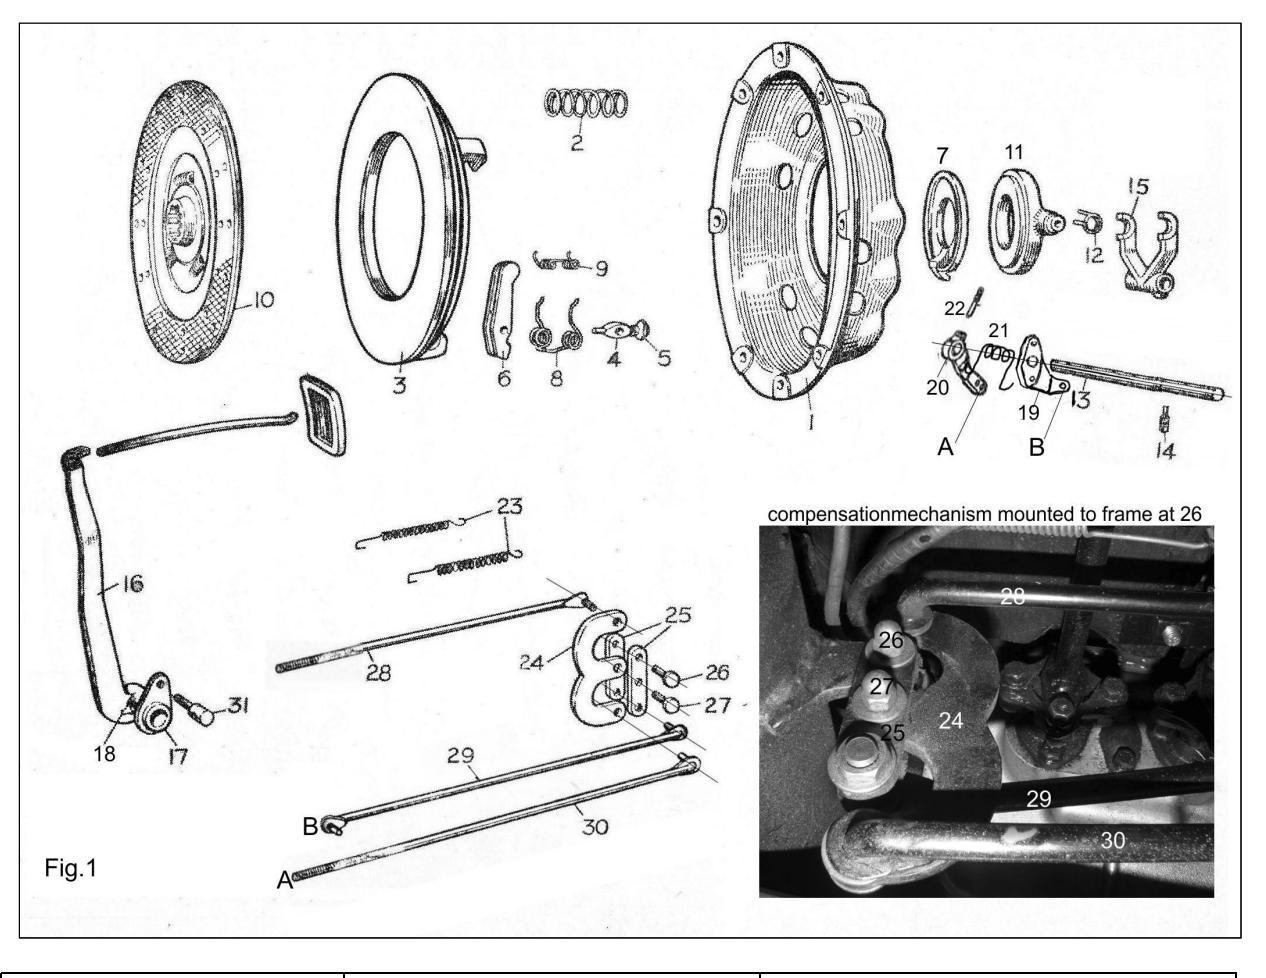
Depressing the clutch pedal results in a pull forward on rod 28. This pulling force not only rotates "E" link 24 and moves rod 30 backwards to actuate the clutch lever 20 but also, by pulling on pin 27, swivels the levers 25 around pin 26 forwards. Rod 29, connected to the lower end of links 25 and at its other end to the clutch housing bracket 19, is thereby pushed forwards, componenting the backwards pulling force on rod 20 (see

pushed forwards, compensating the backwards pulling force on rod 30 (see inserted picture in Fig. 1).

Unfortunately, due to relatively high forces and lack of lubrication, the compensation mechanism is prone to wear and often in need of repair. I drilled out any ovally worn holes in the "E" link and compensation links inserted brass bushes. Depending on the amount of wear select a brass tube size from which the bushes can be cut-off. Most of the wear occurs where the rods 28, 29 and 30 are supported. The pins 26, 27 were replaced by 8 mm bolts and usually wear is minimal at these bores. Furthermore the bent rod ends were provided with screw thread at their ends. By tightening the screw nuts the plates 25 can be adjusted to fit with little clearance to the "E" lever and frame lug and also by tightening the rod nuts a stable arrangement is provided in which rattling of the otherwise loosely assembled parts can no longer occur (see inserted picture in Fig. 1). I used Loctite for the nuts and bolts but you may also find suitable self-locking nuts. Allow some clearance because the movement of the engine/gearbox assembly on the rubber mountings would otherwise put too much stress on the compensation mechanism.

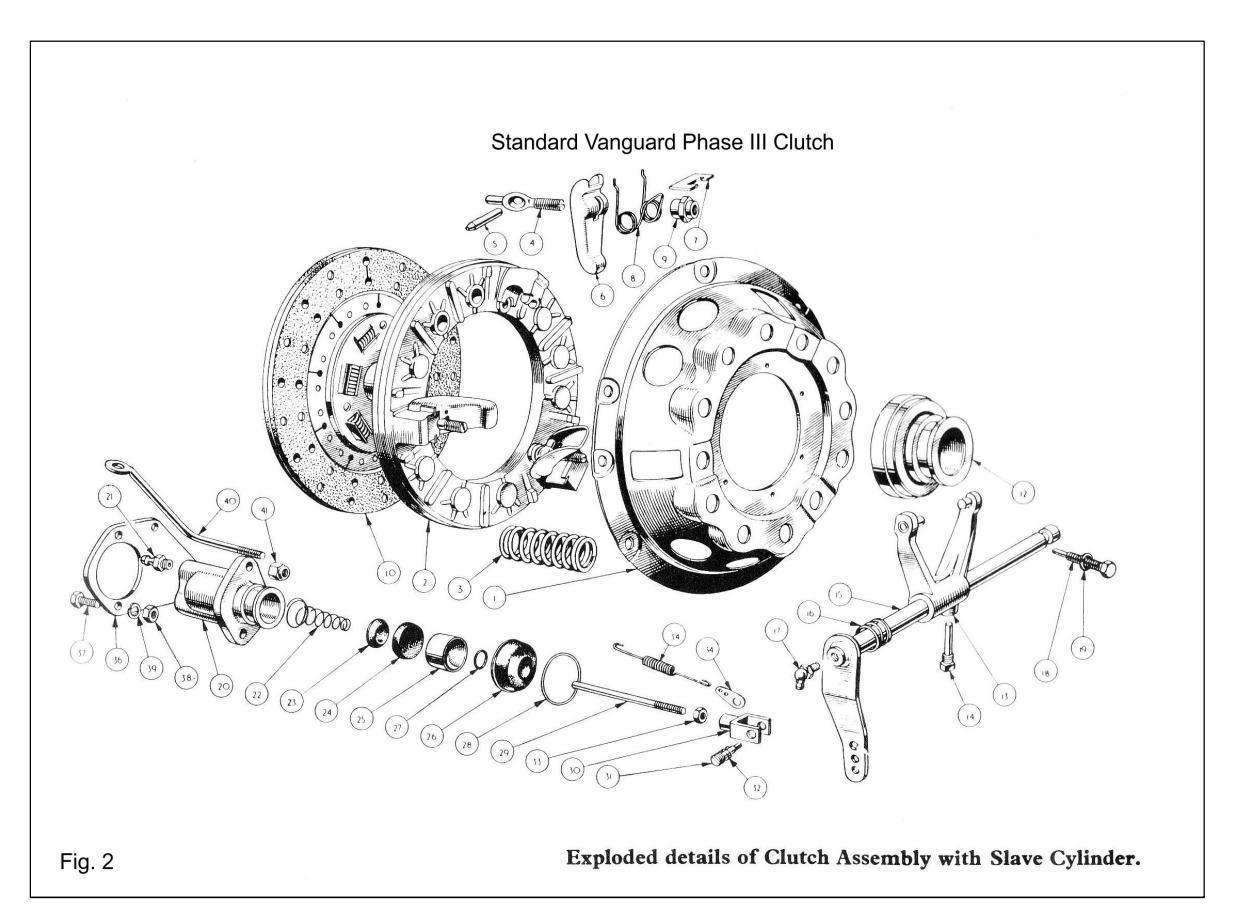
The many rods involved and propensity to wear is perhaps the reason why Standard changed the clutch control in later Standard Vanguard models and the TR2-4 sports cars, to one with a hydraulic slave cylinder mounted directly on the engine-gearbox unit, thereby avoiding the necessity of compensation. Below is a picture of the clutch assembly used on such later models. It includes in addition to the slave cylinder a different release bearing assembly (12) and a modified clutch assembly because no release lever plate (7 in Fig 1) is necessary with this new bearing.

In the later clutch control the slave cylinder is on the left hand side of the clutch whereas the mechanical control was on the right hand side of the clutch. This means that the clutch operating shaft is different when compared to the earlier shaft (the hole for the clutch lever pin 14 is at a different position).
