## More about Roadster brakes and brake bleeding

by Paul Alting van Geusau

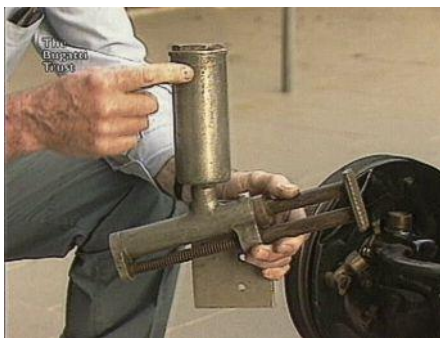
This unique picture is taken from the DVD "Bugatti" by HG (Hugh) Conway (1914-1989), the founder of the Bugatti Trust. It shows the Bugatti "direct action" master cylinder and Mr Conway commented that it "worked quite well but was always giving trouble".

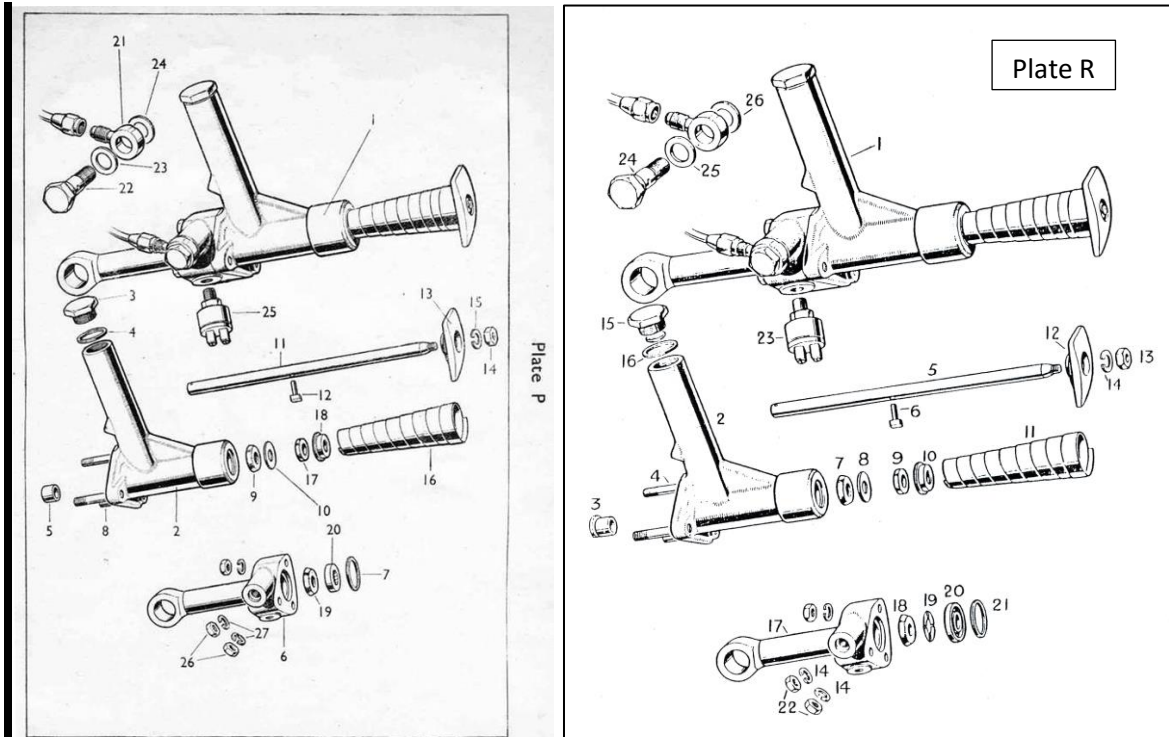
### **The Girling Direct Acting Master Cylinder** (Plates P and R)

Pictures of the Roadster master cylinder are shown below. Quite surprisingly it was found that the master cylinders shown in the different plates published by Girling or Triumph are not identical.

You will see from the above pictures that in Plate P (left) the corrugated washer 19, shown in Plate R, is missing. Nowhere is there an explanation to be found in the relevant literature about the function of this washer. It was argued that the corrugated washer must be in position to protect the rubber seal. Without it, the seal would become perforated by the holes in the brass bush.

This surely appears to be a valid reason but why use a corrugated washer for this purpose instead of a more logical plain washer and why are there axial holes in the guide 20 anyway?

Considering the operation of the master cylinder more in detail let us have a look at the path to be followed by the brake fluid for keeping the pressure chamber (17 in Plate R) filled with fluid. Brake fluid must pass through the radial holes in the end of the plunger rod. In its fully withdrawn position these holes are just behind the lip seal 18 (see plate R above) so as to provide a passage between the inside of the pressure chamber and the space connected to the reservoir.

Plate P comes from the “Standard Triumph Service Instruction Manual” and the manual explains that “The pressure chamber is kept replenished with fluid by the provision of internal splines cut in the guide bearing 20 through which the ram (plunger rod) passes”. It continues by stating that “The extreme end of the ram is recessed and two small ports are provided behind the base of the cup washer to register with the channels of the guide when the ram is in the off-position”. How such “registering” is ensured is difficult to see because the guide 20 is mounted in a bore and there is no information derivable if it can be mounted in only one registered position with respect to the holes in the plunger rod.

Apparently Girling improved its initial design shown in Plate P by replacing the guide 20 with internal splines by a combination of corrugated washer and plain guide bearing 20 provided with axial holes, as shown in Plate R above. Due to these holes brake fluid

freely enters the space between the guide bearing 20 and washer 19. It will be clear that as an effect of its corrugations, the washer keeps a free space filled with brake fluid and fluid also has free access to a small chamber formed in the recuperating seal. When the plunger rod is in its fully withdrawn position the holes in the plunger rod are exactly at the position of this chamber filled with brake fluid. Since the corrugations are on both sides of the washer it does not matter in which way it is inserted between the seal and guide.

The combination of the guide bearing 20 with its axial holes and the corrugated washer 19 is thus essential for the correct functioning of this type of master cylinder as regards free brake fluid flow to and from the pressure chamber 17. In this respect it is also essential that the holes in the plunger rod are located at the position of the chamber of the recuperating seal when the rod is retracted. It is important to check this position because dirt in the runway for the guide block (12 in Plate P and 6 in Plate R) and/or a weak return spring may prevent the plunger rod to arrive at its correct end position (see also Ron Cromar's article in the March 2009 Review).

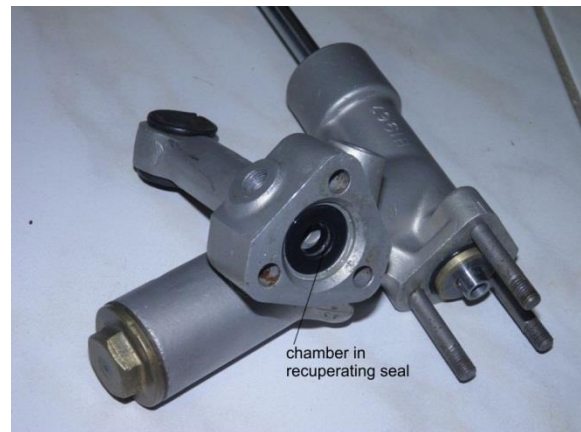
Picture 2 shows that the recuperating seal comprises a small recess forming a chamber around the holes in the plunger rod when it is in its retracted position. So brake fluid can freely flow through the holes in the bronze guide passing the corrugated washer and into the chamber in the recuperating seal and from the chamber through the holes in the plunger rod into the pressure chamber 17.

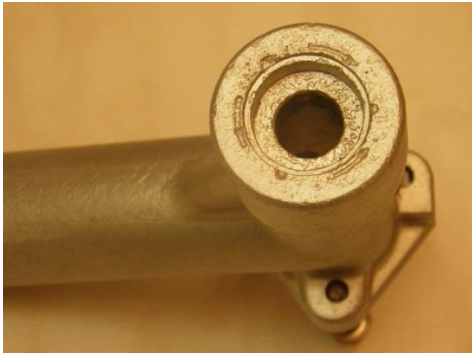
The outer seal sometimes is a source of leakage and mostly the cause is a damaged recess in the master cylinder housing. Picture 3 below shows what corrosion can do to the recess walls and without machining and insertion of a bush, so as to provide a new sealing outer surface for the outer seal, good sealing cannot be assured.

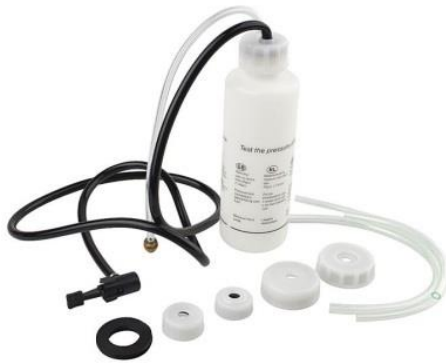
The Eezi Bleed set

The Eezibleed set comes with a number of adapters for connecting the pressurised Eezibleed reservoir to the master cylinder reservoir. Unfortunately none of the adapters fit the Roadster master cylinder but thanks to Mick George (see page 22 of the October 2012 issue of the Triumph Roadster Review) connectors made in aluminium are available at a reasonable price, in particular when considering the quality! So now all Roadster users can use the Eezibleed set for bleeding their Hydrastatic Roadster Brake system!

When the master cylinder is assembled in the correct manner there is no reason why bleeding should give a problem. The holes in the plunger rod are quite small so some pressure might help to ease the bleeding operation. Triumph Roadster Manual recommends using the Eezi Bleed system with 30 psi pressure.
