## Roadster 2000 clutch control

## by Paul Alting van Geusau

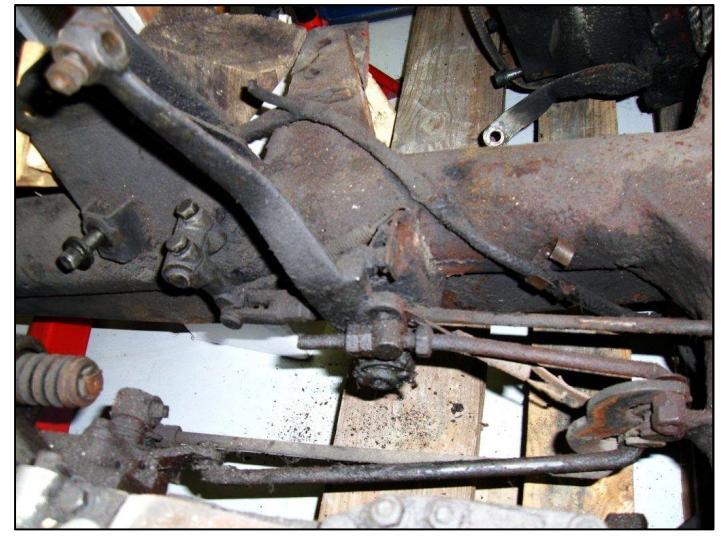
Unfortunately, due to relatively high forces and lack of lubrication, the compensation mechanism is prone to wear and often in need of repair. I drilled out any ovally worn holes in the "E" link and compensation links inserted brass bushes. Depending on the amount of wear select a brass tube size from which the bushes can be cut-off. Most of the wear occurs where the rods 28, 29 and 30 are supported. The pins 26, 27 were replaced by 8 mm bolts and usually wear is minimal at these bores. Furthermore the bent rod ends were provided with screw thread at their ends. By tightening the screw nuts the plates 25 can be adjusted to fit with little clearance to the "E" lever and frame lug and also by tightening the rod nuts a stable arrangement is provided in which rattling of the otherwise loosely assembled parts can no longer occur (see inserted picture in Fig. 1). I used Loctite for the nuts and bolts but you may also find suitable self-locking nuts. Allow some clearance because the movement of the engine/gearbox assembly on the rubber mountings would otherwise put too much stress on the compensation mechanism.

The compensation arrangement as found on the 1800 Roadster (before restoration)
